6.0 JHT and UTILITIES

6.1. Capital Work

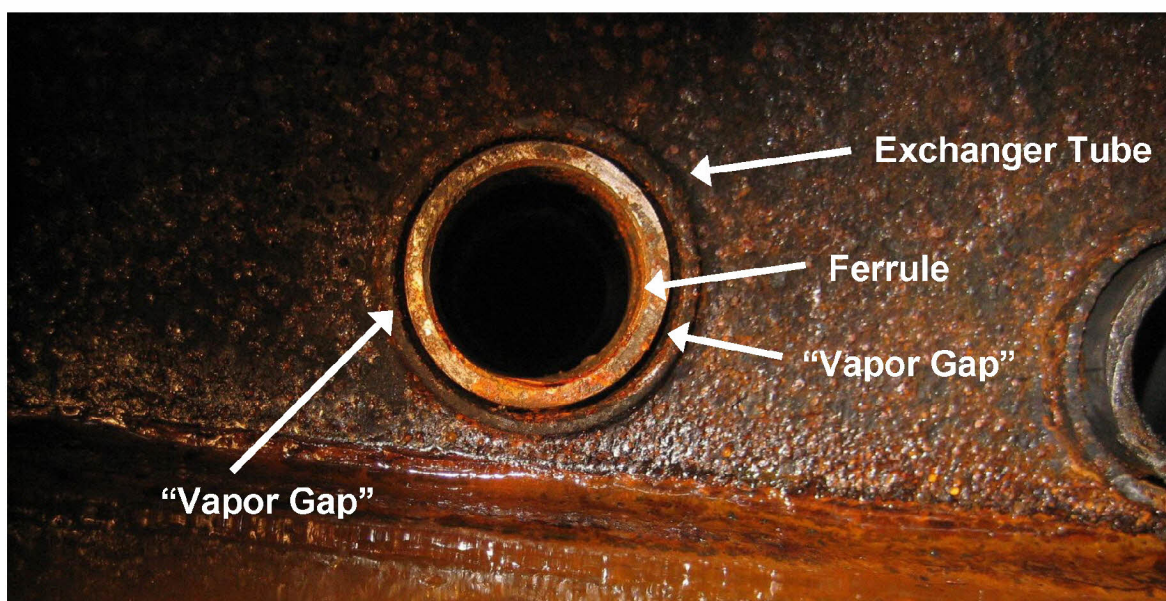
The ferrules were installed in a few days by CMS. After the ferrules were installed, questions arose about whether the repair was valid. A meeting was called with Inspections (Dan Mason, Joe George), Engineering (Garth Jolly, Craig Dillon, Matt Greenfield, Doug Shotwell), and Materials (Pete Risse, Jessica Stankiewicz). Pete Risse was unconvinced that the ferrules were adequate to prevent further corrosion from Perchloroethylene. The "vapor gap" between the outside of the ferrule and the inside of the tube was viewed as an area where corrosion could continue (see **Figure 6.1.1.1**). It was decided in the meeting that no ferrule (alloy, carbon steel, thin-walled, thick walled, etc.) would relieve these fears and that a retube was necessary.

Peter Risse, materials engineer, believes that the corrosion mechanism is caused by chlorides that enter the JHT as 1 S/C "Hot Feed" from #4 Crude Unit. This stream enters the JHT downstream of V-220, a high pressure separator, and upstream of C-240, the Jet Splitter. This explains why there is no corrosion in E-216, the reactor effluent cooler. It was the reactor effluent cooler in the NHT that experienced rapid corrosion rates during the high chloride event in that unit. Because the E-216's showed no corrosion, we were at a bit of a loss as to the cause and mechanism of the corrosion.

Figure 6.1.1.1 Photo showing the infamous “vapor gap” between the outside of the ferrule and the inside of the exchanger tube.

The retube was performed by Phoenix Services out of Texas, who received a strong recommendation from Pascagoula’s Reliability Group. In addition to the high recommendation, Phoenix Services was selected based on their ability to start immediately and work a day and night shift. The only other contractor we could get to consider this job was Matrix. They could not start for another two weeks and could only work day shift.

The bundles were replaced in-kind with 1 ¼” OD x .109” min. wall SA-179 tubes with embedded (non-serrated) aluminum fins. During the removal of the old tubes, some mechanical damage was noted on the tubesheet. A “go – no go” gage was fabricated and used to determine the integrity of the tubesheet based on API and TEMA tolerance specifications. Based on this data, two holes in the tubesheet were plugged and seal welded (without tubes).

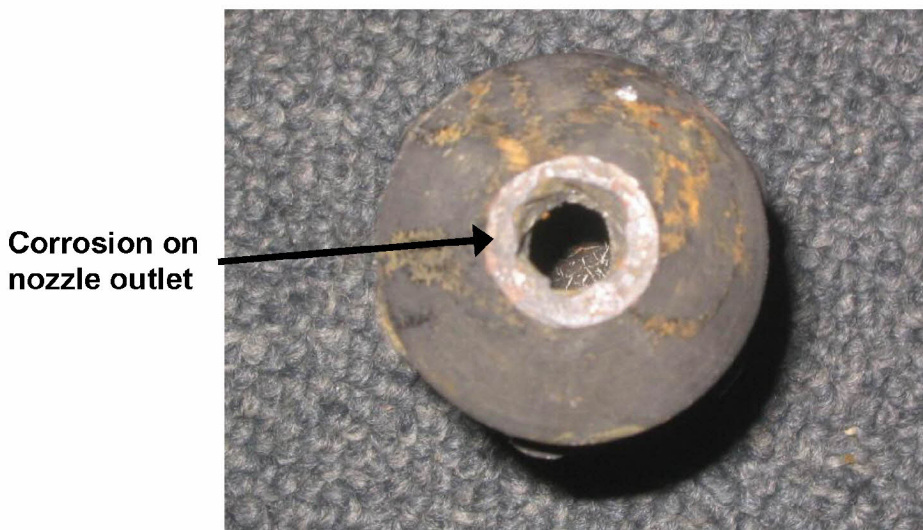
The water wash piping on the E-216 fin fans was replaced due to corrosion under insulation. The replacement was in-kind, except for the injection quill, which was upgraded to Hastelloy C. The design of the injection quill was also modified to allow the nozzle to sit into the center of the process pipe and shoot downward, with the flow of process. This change was made to accommodate “best practices” that were written after the original design was installed. The Hastelloy C upgrade was necessary per conversations with Peter Risse in Materials. The old carbon steel nozzles did have significant corrosion upon removal.

Figure 6.2.6.1. Corrosion on old carbon steel E-216 water wash nozzles

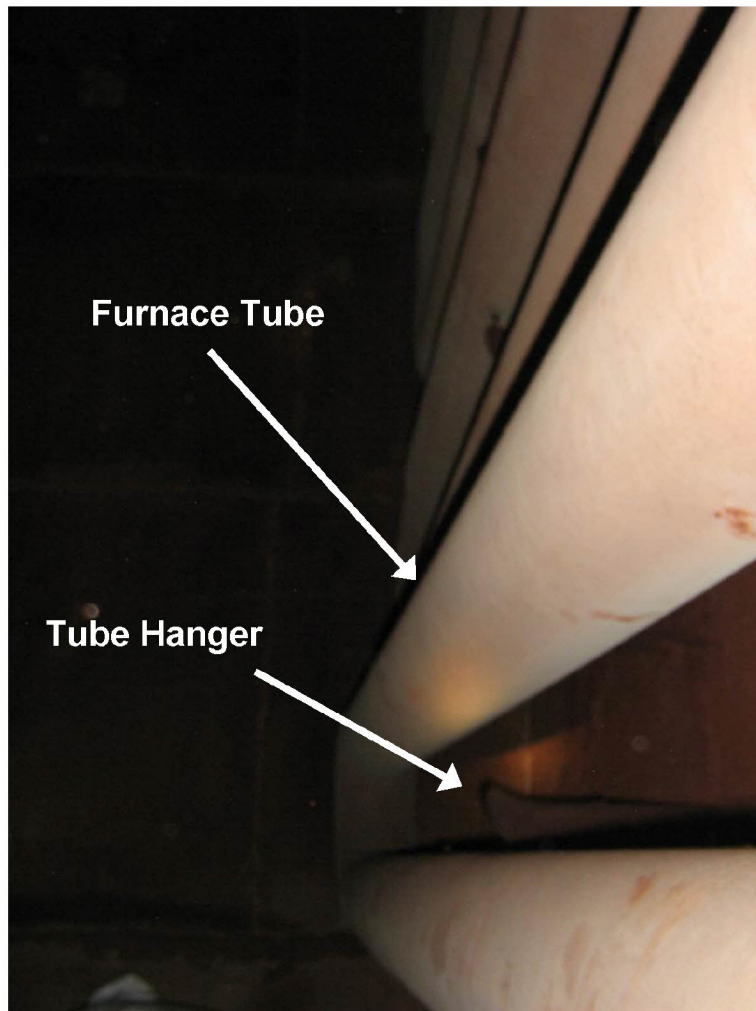
Furnaces were in good shape overall. There were some small refractory and snuffing steam repairs. It was noted in F-210A that one of the tubes is not sitting on the hanger. This was also observed in the 2002 S/D, so we did not perform any repairs. There were some bad burners that can be replaced on the run.

Figure 6.3.1.2. Tube not sitting on hanger in F-210A.

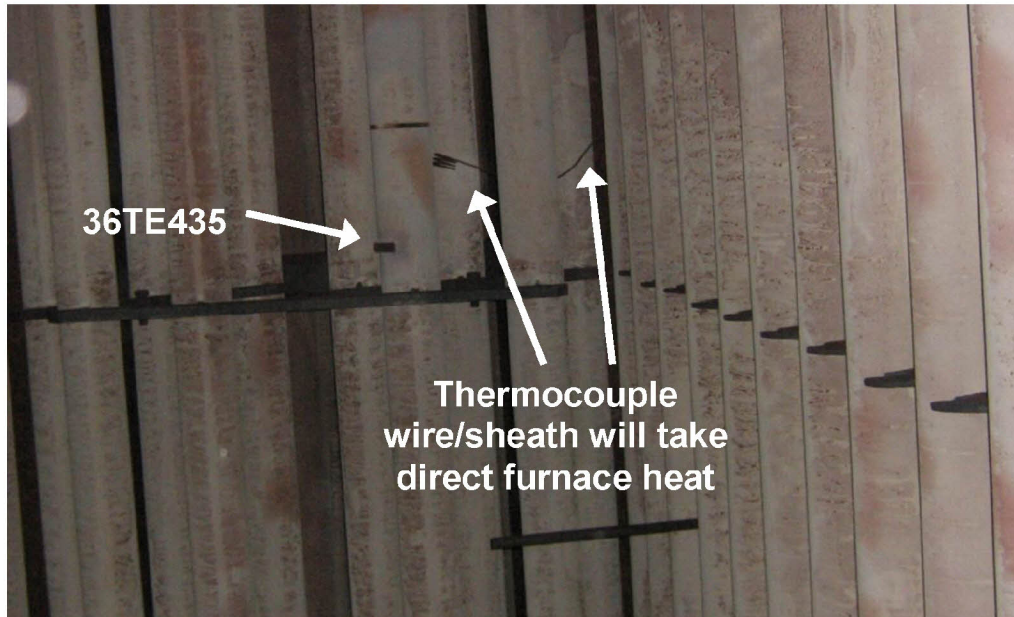
The I&E department replaced damaged furnace TI's 36TE435 and 36TE416. TI 36TE435 is located on a roof tube and does not run along the tube and out of the furnace. It is strung perpendicular to the tubes and thus is directly exposed

to the heat from the burners below. If this TI fails again, a redesign would be appropriate.

Figure 6.3.6.1. Photo taken from the floor of F-247 looking up toward the furnace ceiling.

RECOMMENDATION: Redesign the location or route of 36TE435 if the Ti fails again.

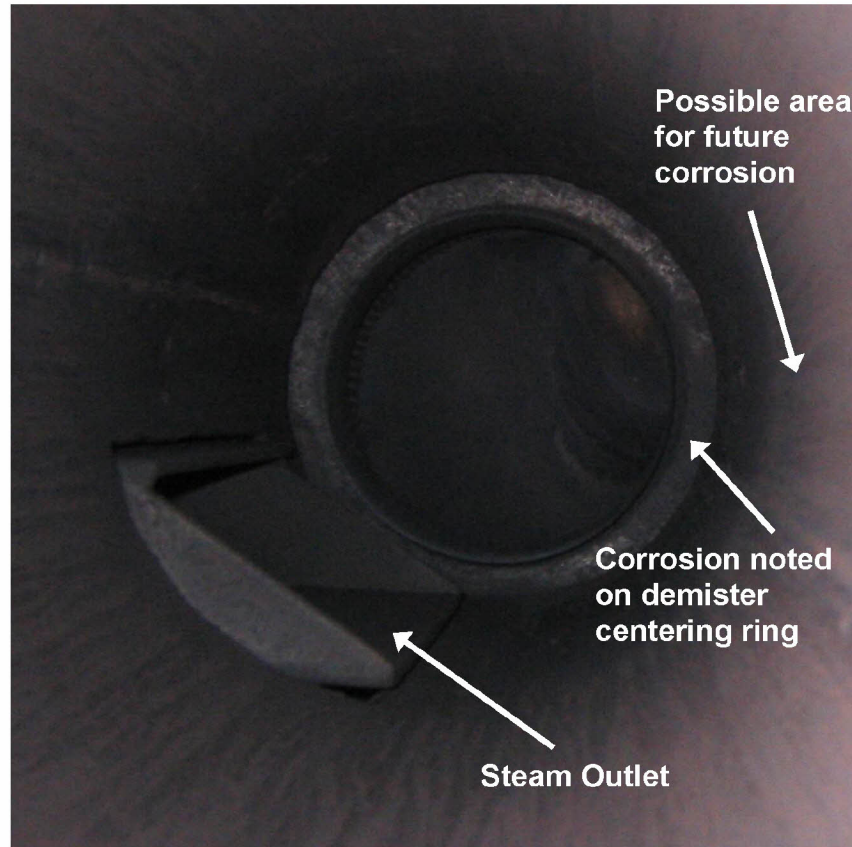
There was some corrosion noted on the inside of the steam cyclones where the steam is injected – see **Figure 6.4.1.1**. The corrosion was limited to the centering ring for the demister screen on top of cyclones, so we took no corrective action this shutdown. However, with the centering cylinder corroded

away, the corrosion could spread in the next few years to the outside cylinders, compromising their integrity.

Figure 6.4.1.1. This photo shows the inside of one of the cyclones. The photo was taken from the bottom of the cyclone looking up toward the demister pad.

RECOMMENDATION: Be aware that cyclones may need replacement next turnaround due to corrosion. Ensure replacement parts are readily available or have replacement parts on-hand.

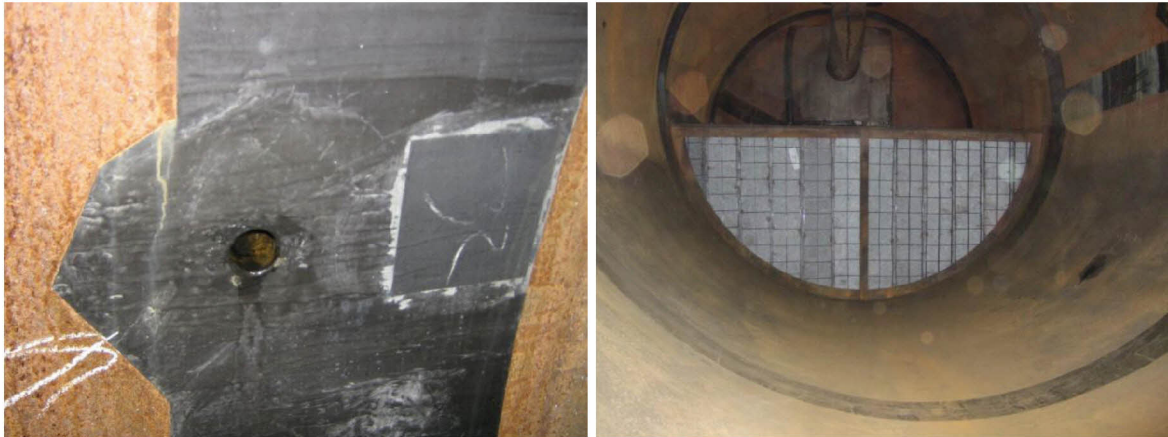
V-220 was inspected and found to be in good condition. The Belzona coating that was installed in 2000 was almost all intact (see **Figure 6.4.2.1**). One small section was missing on the impingement plate weld (this may have been

Figure 6.4.2.1. Photos of the Belzona coating and the new coalescer pad.

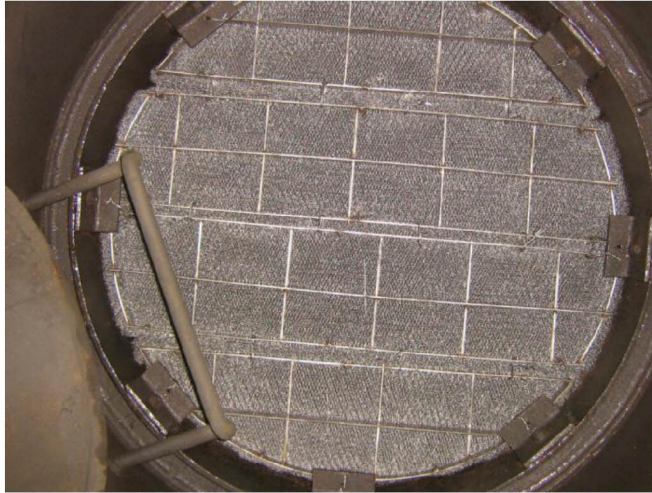
This vessel was cleaned and inspected and had no notable problems. The only work performed was to replace the demister pad (see **Figure 6.4.5.1**).

Figure 6.4.5.1. This shows the new demister pad as viewed from the bottom of V-243 looking up.

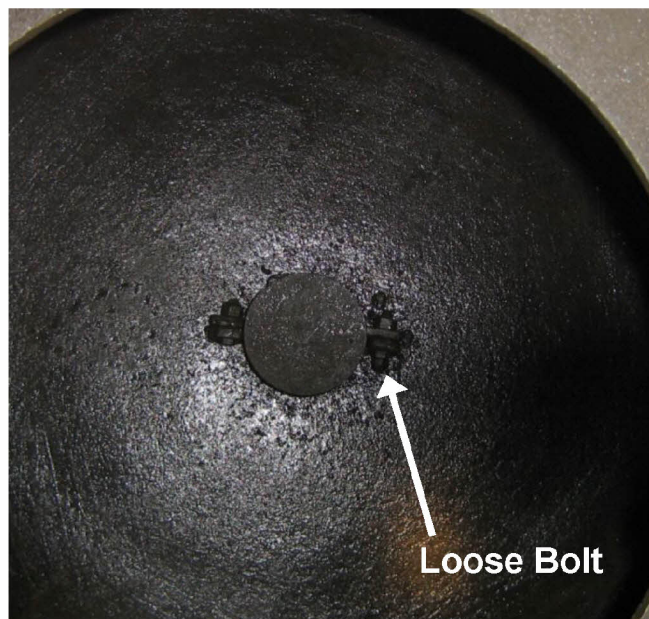
This vessel was cleaned and inspected. The only work performed was to replace the demister pad. There was one loose bolt on the bottom of the vessel. The bolt was tight to the nut but was not clamping correctly (see **Figure 6.4.6.1**). Because the nut was tight and we didn't want to shear the bolt, we decided to leave it loose. In order for the vortex breaker to move, both bolts would need to fail.

Figure 6.4.6.1. Photo of the bottom of V-244.

RECOMMENDATION: Check that both bolts are still installed on the vortex breaker / witches hat on the bottom of the vessel next time it is opened.

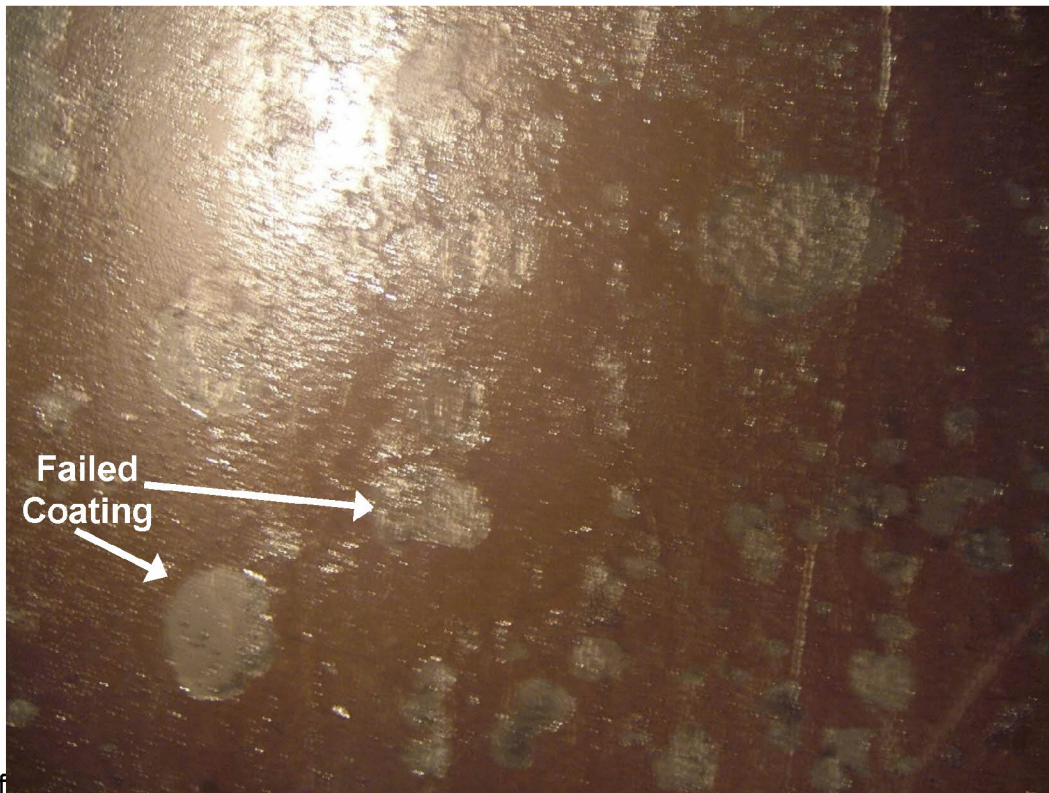
During the last run, the internal coating of V-3215 failed. The coating appeared to have failed in large spots (1"-9" diameter). **Figure 6.4.7.1** shows the failed coating.

Figure 6.4.7.1. Failed coating in V-3215.

It was determined to replace the coating in-kind with Dampney Apexior Number 1, as the coating is the best solution for the service. The determination was that the last application must have failed either due to inadequate surface preparation or improper curing. The Dampney procedure has a lengthy and complex curing process.

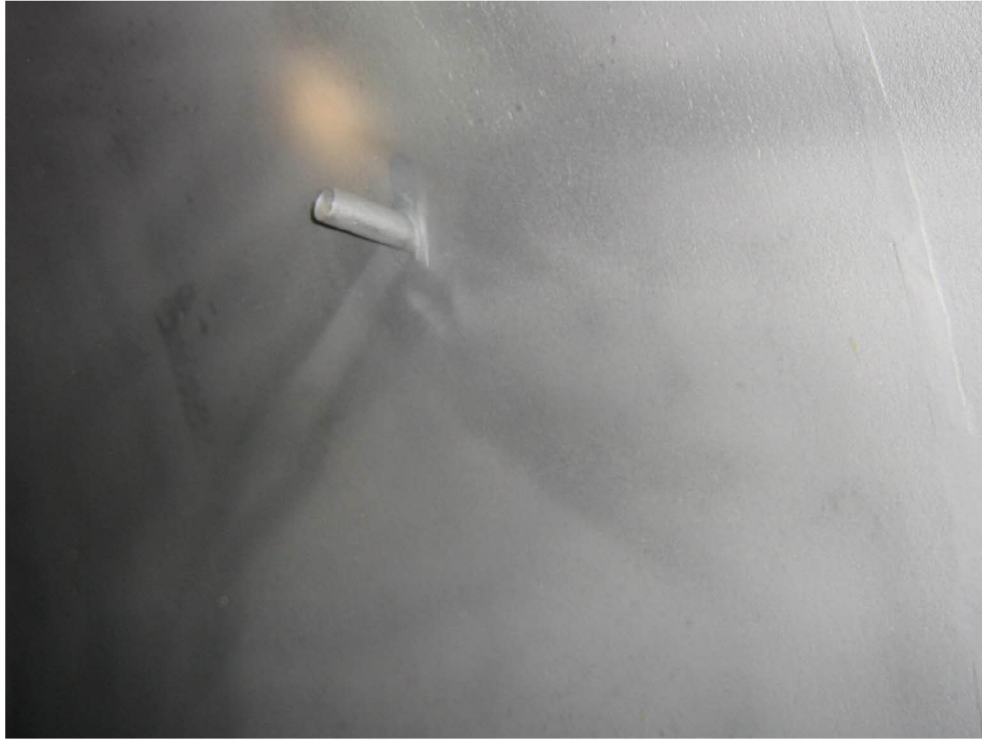
Figure 6.4.7.2. Picture of the new coating. – Dampney Apexior Number 1.

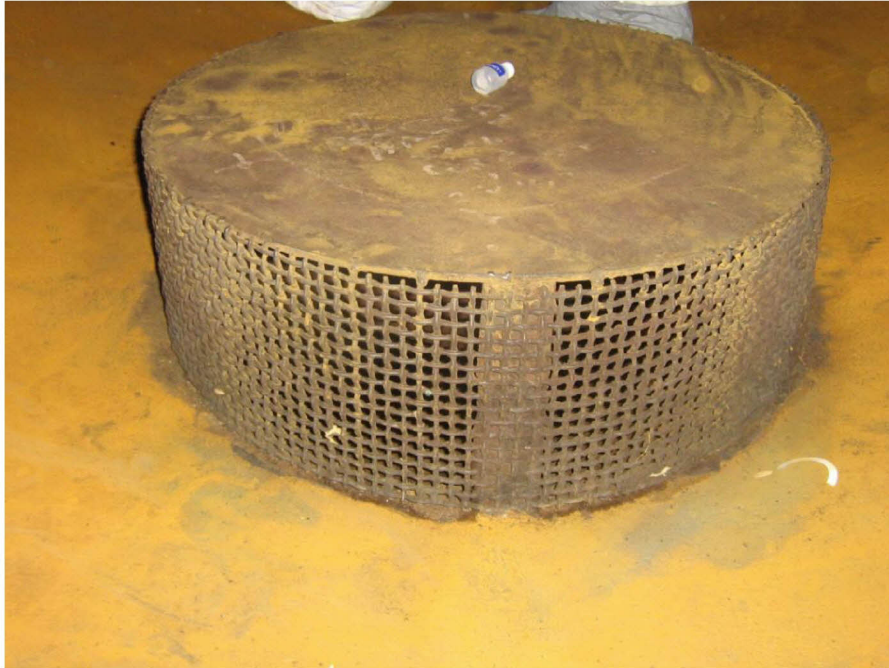
In order to coat the bottom outlet of the vessel, it was necessary to remove a strainer that was over the vortex breaker. After conversing with Kansas City Deaerators (KCD), it was determined not to reinstall the strainer. Strainers are not typically installed on similar vessels and Kansas City Deaerators does not install them in new deaerators. The vortex breaker was seal welded and felt very rigid. The photos show before and after the strainer was removed. See **Figures 6.4.7.3 and 6.4.7.4.**

Figure 6.4.7.3. Strainer covering the water outlet of V-3215.

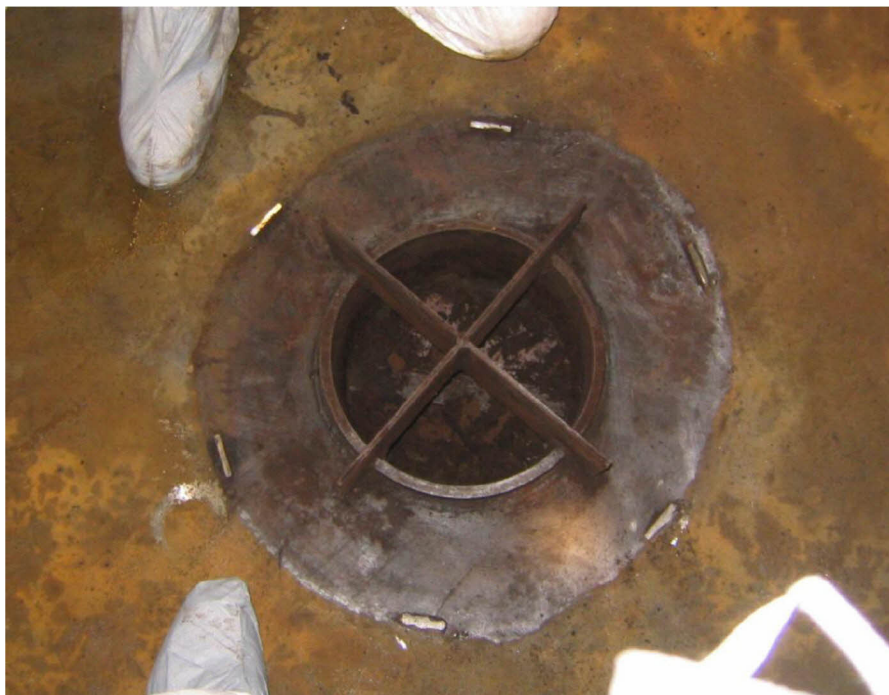
There was some pitting noted in the bottom of the vessel. The largest pit measured 0.18" deep. This pitting should be monitored so that it doesn't become too deep.

Figure 6.4.7.4. View of the water outlet without the strainer.

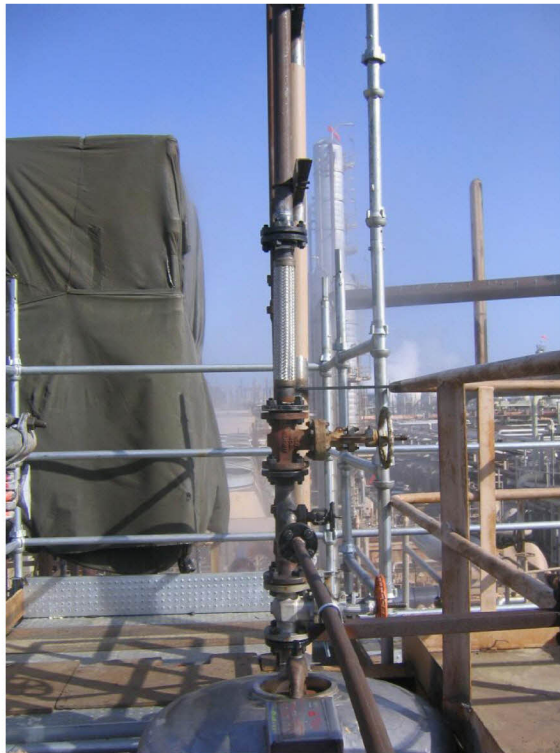
One month after start-up, the deaerator experienced a major leak in the top dome. The dome had several cracks propagating from the 2" vent nozzle. After closer inspection, it was revealed that the deaerator had cracks in the head, 2" nozzle piping, and around the 8" water nozzle. It was the opinion of

inspections and metallurgy that the cracks were fatigue induced, not chloride cracking. The entire platform that the deaerator sits on experiences vibration that causes the 8" line and the 2" vent to shake back and forth, stressing the head. Also, there was a separate loud, fast vibration that appeared to be coming from inside the vessel that started right after startup. It is possible that the vibrations either helped propagate or caused the cracking. There was also a one time "event" that occurred in the deaerator that caused extremely loud noise and vibrations to come from the vessel. This "event" occurred when the vessel experienced level control issues. It is possible that the cracks developed during this "event".

Figure 6.4.7.5. New Vent Stack

The final repair consisted of cutting the head off of the vessel 1 7/8" above where it was originally welded to the dome cylinder. This was done to avoid disturbing the weld for the 8" nozzle. The dome cylinder required some grinding and weld building around the 8" nozzle but none of the cylinder was replaced. A portion of the 1 7/8" of the remaining original head was cut out and a patch was welded in its place. This repair was directly above the 8" nozzle. The 2" vent was cut below the head and a new pipe and flange were welded on. A portion of the vent was replaced with 2" flexible S.S. hose to dampen the vibrations and reduce the stress on the head. The vent support was also improved. See **Figure 6.4.7.5**.

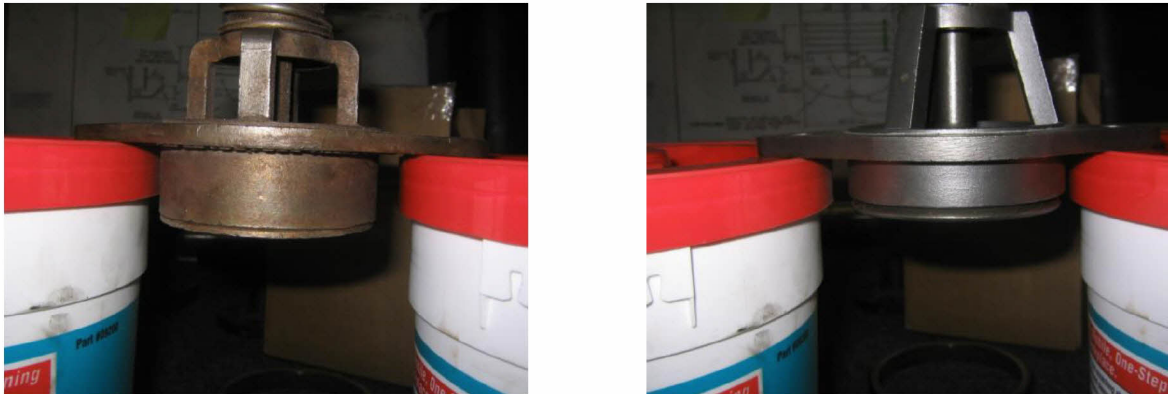
The stiffness of the Pemco valves were compared to the stiffness of the KCD valves and were found to be less than half as stiff as the KCD nozzles. See **Figure 6.4.7.6**. As a result of this test, all of the KCD nozzles in the vessel were replaced with Pemco nozzles. The loud, high frequency vibration stopped after the vessel was started back up. This leads us to believe that the KCD nozzles were too stiff (and possibly chattering) and caused the vessel to vibrate. Pemco nozzles should be used in the future and no parts should be ordered from Kansas City Deaerators.

Figure 6.4.7.6. The KCD valve on the left and Pemco valve on the right are both loaded with 2 lbs. At this load the Pemco nozzle is open and would be spraying water. The KCD valve does not even crack at this load.

RECOMMENDATION: Order all spray valves in the future from Pemco Design Services. Do not order any replacement parts from Kansas City Deaerators.

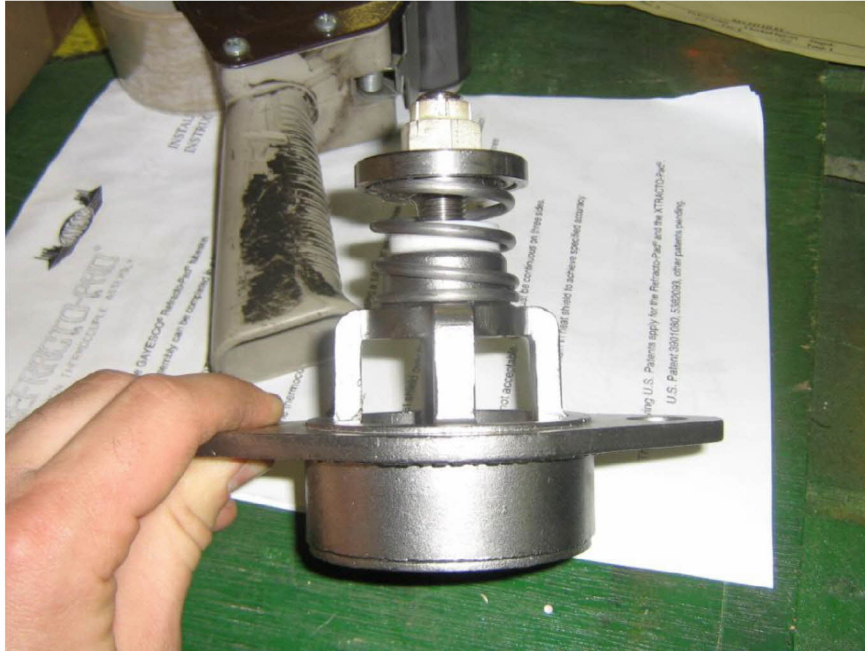
Figure 6.4.7.7. New 316 S/S spray nozzles from Kansas City Deaerators. Nozzles were too stiff and were replaced with nozzles from Pemco Design Services.

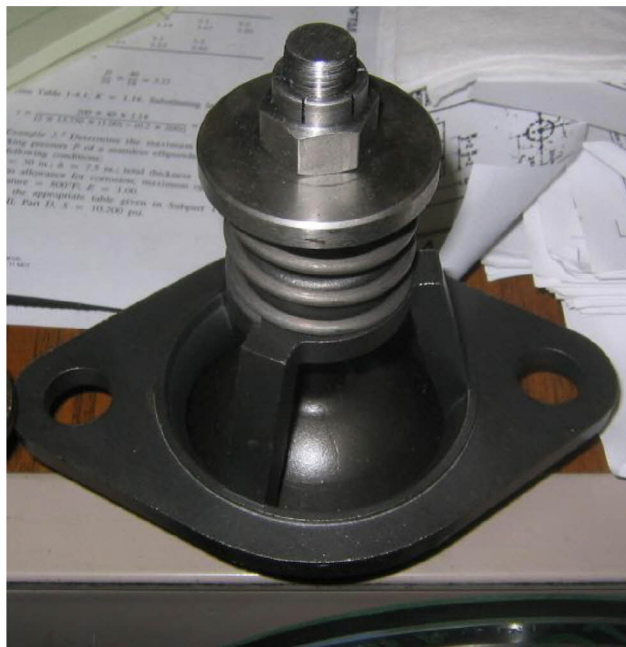
Figure 6.4.7.8. New 316 S/S nozzles from Pemco Design Services. These nozzles should be used in the future.

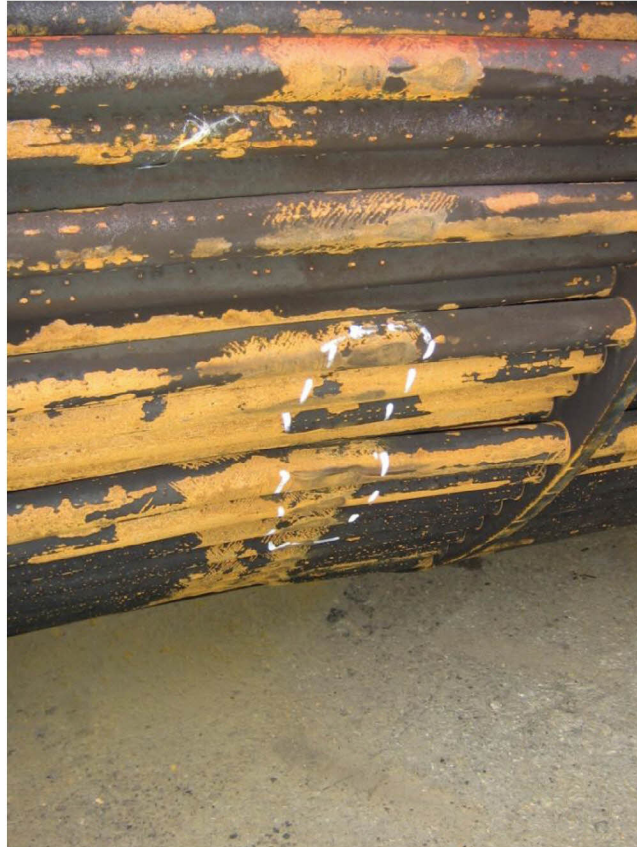
E-211A was opened, cleaned, and inspected. The channel and shell were in good condition. Inspections reported 20-29% wall loss in 3 tubes and estimated a half wall life of 8.75 years. In the bundle, two tubes were vented and plugged due to rigger corrosion. It appeared that the lifting strap was placed across the tubes, rather than across the baffles. The lamiflex was replaced and the width was changed in the database from 1.75" to 2".

Figure 6.5.1.1. Rigger damage on E-211A tube bundle.

RECOMMENDATION: Evaluate a possible retube due to thinning tubes. Inspections estimates half life in 8.75 years (for 3 corroded tubes).

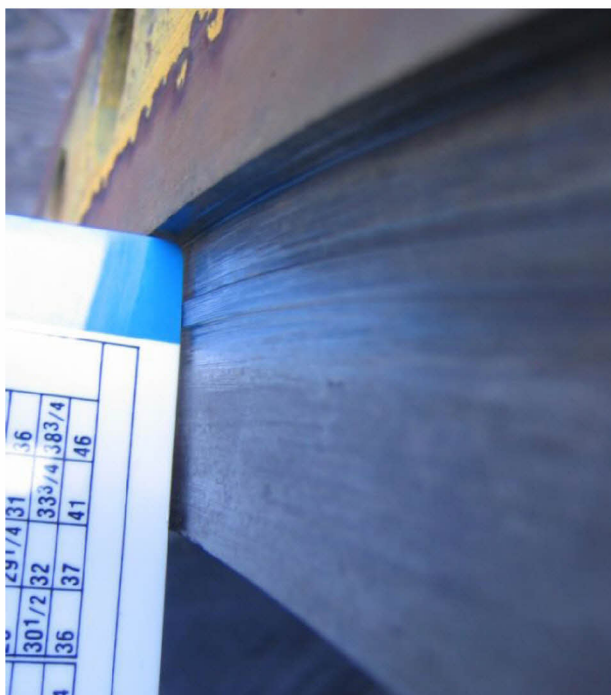
The shell nubblins were removed in the field by Dresser Rand Field Services. Both shells were significantly out of round and not flat. This resulted in slightly more metal being removed than we would have preferred (~.020"). The final depth of the gasket surface in relation to the flange face was .225" on E-412A and .221" ave on E-214 B. All gasket and torque information was updated on the Heat Exchanger Data Base.

Figure 6.5.3.1 Nubbin on E-214A shell before removal.

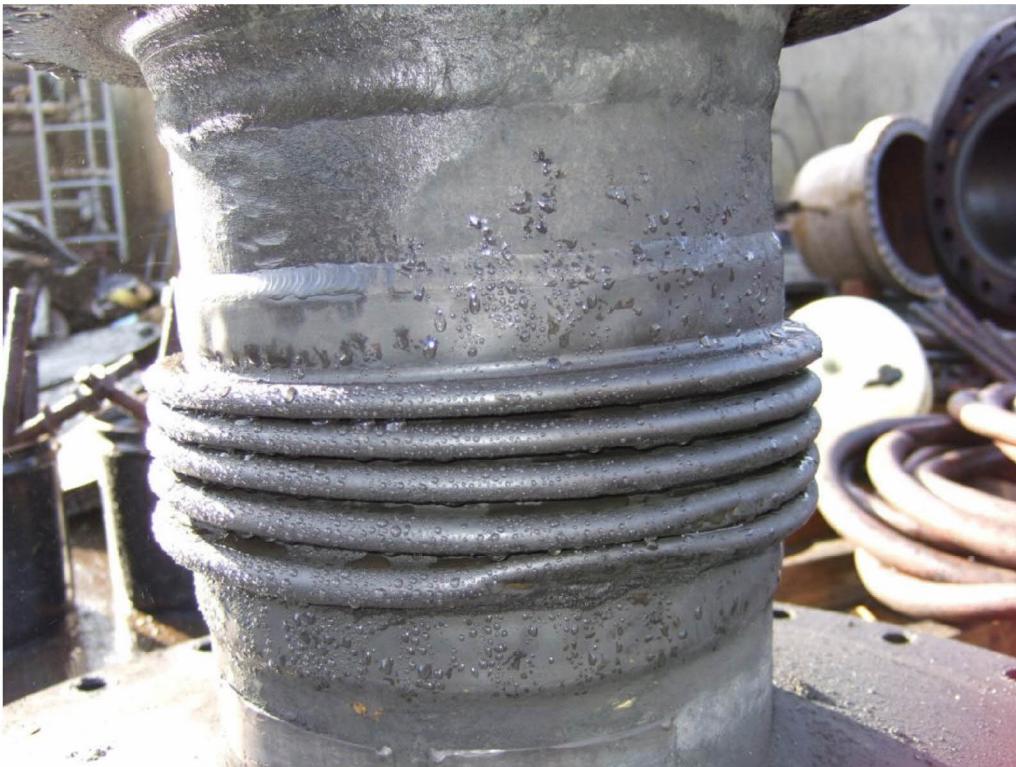
Exchanger was pulled, disassembled, cleaned, and inspected. During disassembly, the exchanger bellows was damaged. A new bellows was ordered from Expansion Joint System. Benicia Fabrication installed the new

Note: there is always good value in watching the contractor pull apart heat exchangers with bellows and talking with them to make sure they understand how they come apart. The damage to the bellow was accomplished with a pry bar and easily avoidable. The damaged bellows added about \$25,000-\$30,000 to the job.

Figure 6.5.11.1. Damaged bellows after removal.
